#### **TEST REPORT**

**Report No.**: C8079.01-201-44

AMERICAN GARAGE DOOR SUPPLY, INC. Bemidji, Minnesota

PRODUCT TYPE: Polycarbonate Section Overhead Garage Door SERIES/MODEL: 20'2" x 8'0"
DESIGN PRESSURE: +21.3/-18.0 psf

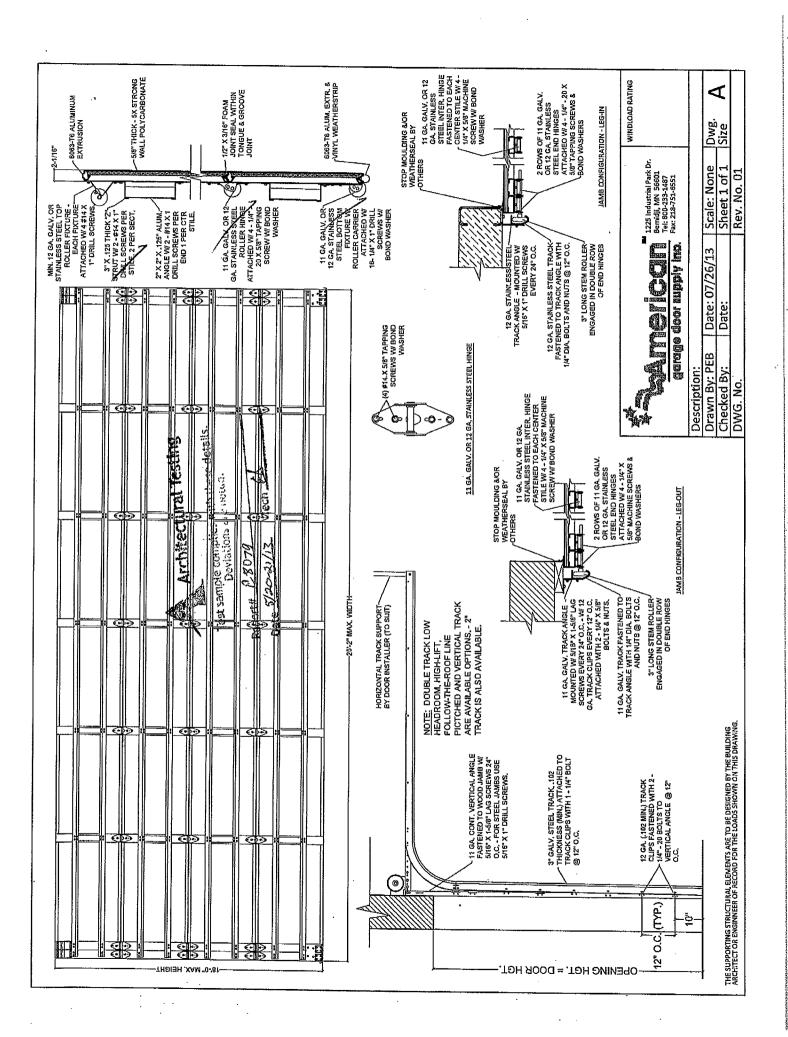
**Drawings**

## **5.0 Test Specimen Description**: (See Attached Drawing)

Panel Member	Material	Description
Frame	Aluminum	
Infill	Polycarbonate	Five wall polycarbonate.
Intermediate stiles	Aluminum

Joinery Type	Detail
Frame corners	Butt	Secured with three #8 x 1/2" screws and one #14 x 3/4" thread cutting screw.
Intermediate stiles to frame	Butt	Secured with four #8 x 1/2" screws.

- **3.6 Test Sample Source**: The test specimen was provided by the client. Representative samples of the test specimen will be retained by Architectural Testing for a minimum of four years from the test completion date.
- **3.7 Drawing Reference**: The test specimen drawings have been reviewed by Architectural Testing and are representative of the test specimen reported herein. Test specimen construction was verified by Architectural Testing per the drawings located in Appendix C. Any deviations are documented herein or on the drawings.
